**AIRWORTHINESS DIRECTIVE**

No. 2024-AHCAT, AHCAT-CK-09

Applicability – ANSAT helicopters (ANSAT, ANSAT-GC models)  
Designer's State - RUSSIAN FEDERATION

**TECHNICAL DECISION No. 1/144-2024-KB3**  
on continued airworthiness of the ANSAT helicopters (ANSAT, ANSAT-GC models)

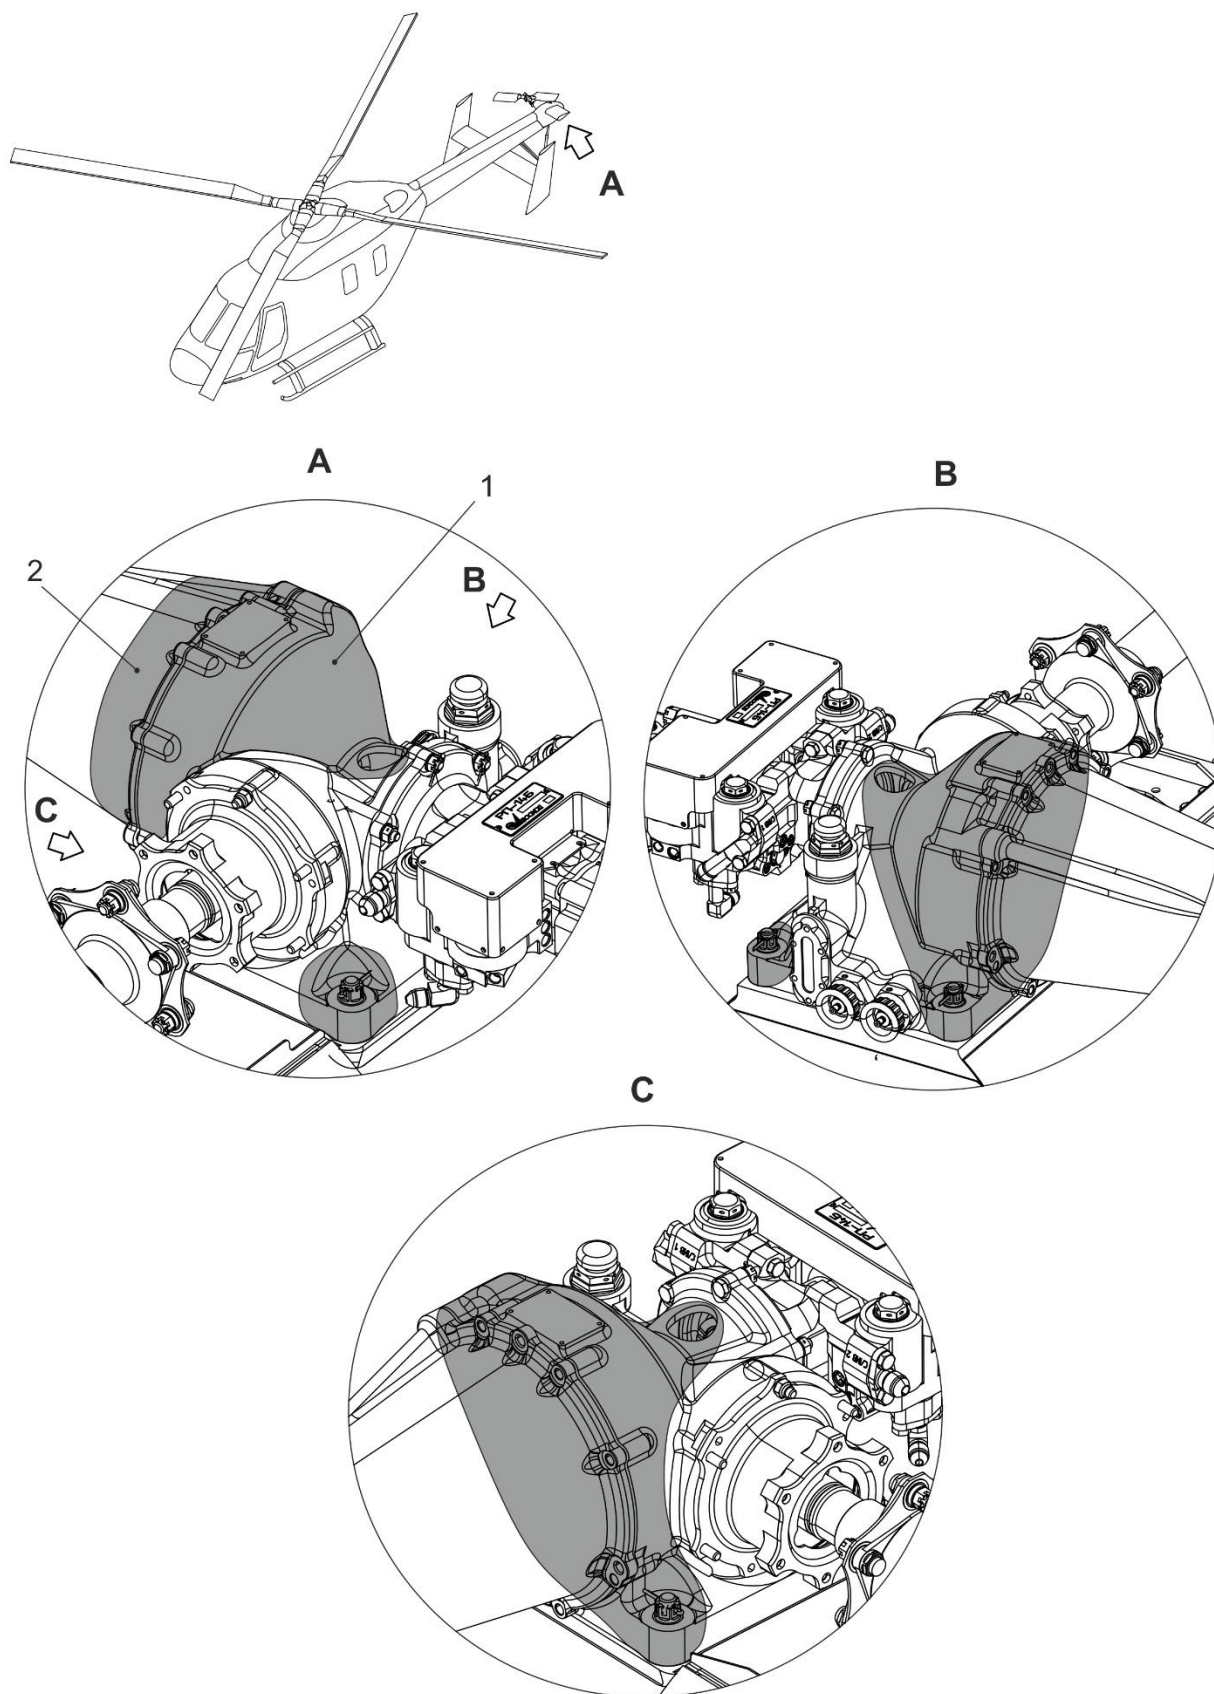
Figure 201 – Visual inspection of XP-23 tail gearbox casing and cover

| Temporary task card 065.20.00k | | |
|---|---|---|
| <p>1 Remove the tail rotor (see TC No. 064.20.00c).<br/> 2 Install the tail rotor on the trestle.<br/> 3 Remove the left and right fairings of the tail gearbox.<br/> 4 Clean the tail gearbox casing.<br/> 5 Inspect the tail gearbox casing (1) joint with cover (2), as well as casing (1) joints with the tail boom (indicated by the color in figure 201).<br/> Presence of cracks, nicks and corrosion damages on the surfaces of the parts is not allowed.</p> <p>6 Install the left and right fairings of the tail gearbox.<br/> 7 Install the tail rotor (see TC No. 064.20.00d).</p> | | <p>If any defects are detected, take photographs of them and send together with the inspection report to JSC “Kazan Helicopters” to make a decision on the possibility of further operation.</p> |

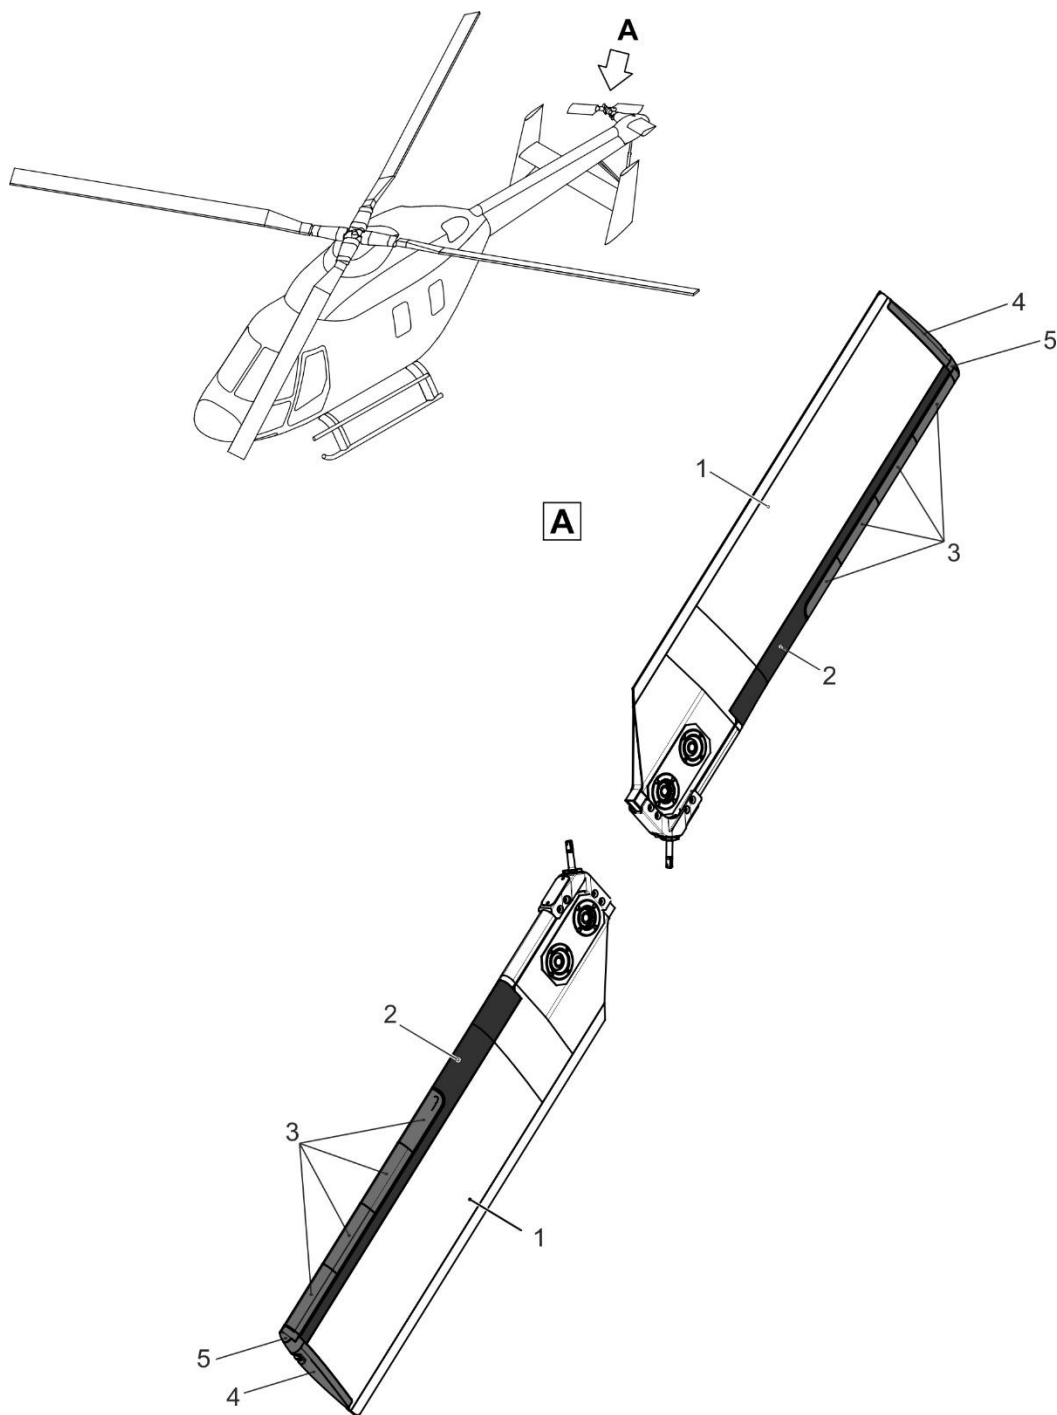
Figure 203 – Tail rotor blade

| Temporary task card 064.10.00k | | |
|---|---|---|
| <ol style="list-style-type: none"> <li>1. Remove the tail rotor (see TC No. 064.20.00c).</li> <li>2. Perform visual inspection of tail rotor blades (see TC No. 064.10.00c).</li> <li>3. Perform a visual inspection of the condition of the rubber layer of strips (2) (see figure 203) of the tail rotor blades (1) for absence of damages.<br/>Crumbling of the rubber layer with a total area of no more than 10 cm<sup>2</sup> with the size of a single crumbling with an area of no more than 2.5 cm<sup>2</sup> and a width of no more than 0.5 cm is allowed.</li> <li>4. Perform visual inspection of condition of tips (4) and blade edge tippings (5) of tail rotor blades (1). Pay special attention to the blade edge tipping (5) fastening screws on the blade tip (4).</li> <li>5. Check the absence of non-glueing of rubber layer of the strips (2) and blade edge tippings (3), as well as glue joint of tips (4) and blade edge tippings (5) of tail rotor blades (1) by tapping with a duralumin hammer, proceeding as follows: tap the entire rubber area of the strips (2) and blade edge tippings (3), as well as tips (4) and blade edge tippings (5) with a free fall of the duralumin hammer from a height of no more than 10 ... 15 mm or with soft blows from a distance of no more than 10 mm, avoiding traces of tapping. Violation of glueing is characterized by a change in tone.<br/>The presence of non-glueing is not allowed.</li> <li>6. Install the tail rotor (see TC No. 064.20.00d).</li> </ol> | | <p>If any defects are detected during the inspection according to pp. 2 - 5, fill in the chart of tail rotor blades inspection (see figure 202), take photos of the defects. Make marks on the tail rotor blades with a soft pencil.</p> |
