**AIRWORTHINESS DIRECTIVE**

No. 2025-FATA-010144R-06

Applicability – ANSAT helicopters (ANSAT, ANSAT-GC models) and their modifications  
Designer's State - RUSSIAN FEDERATION

**TECHNICAL DECISION No. 1/144-2025-KB3**  
on continued airworthiness of the ANSAT helicopters (ANSAT, ANSAT-GC models)

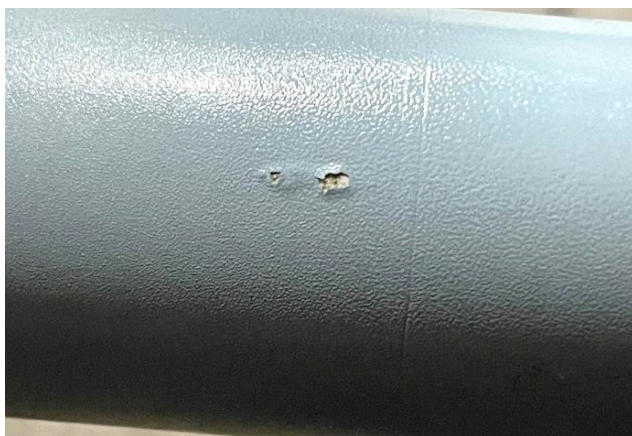
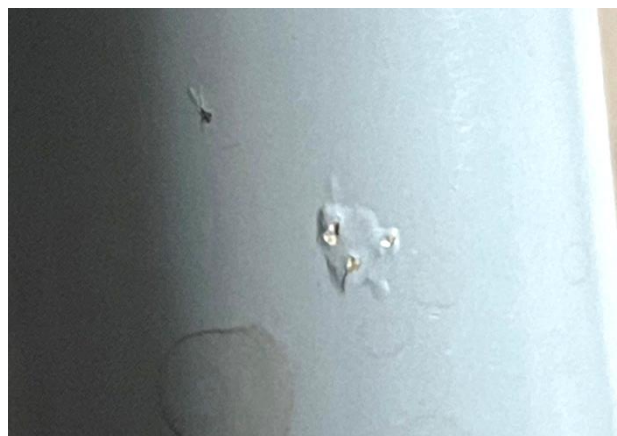
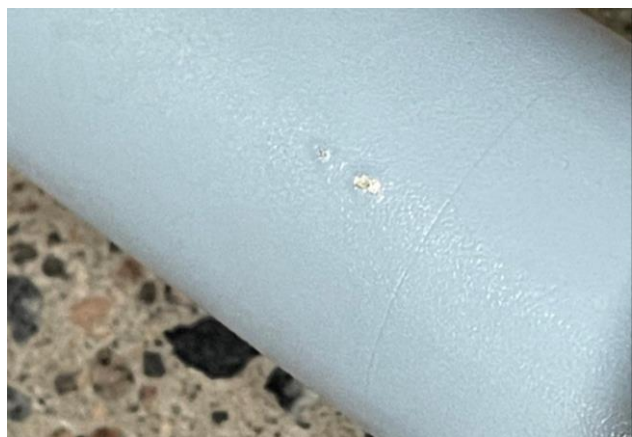
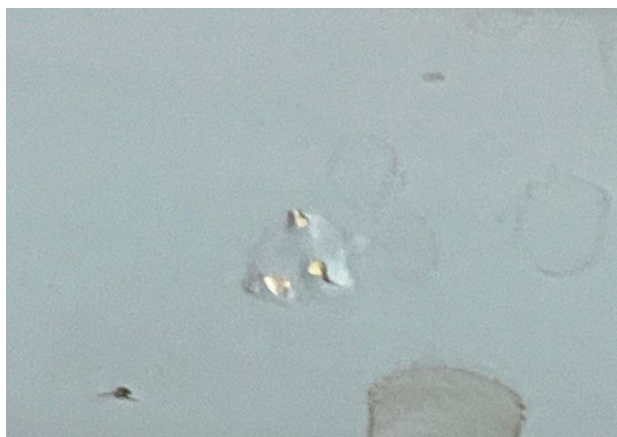
**Figure 202 – Examples of defects**

In case of detection of corrosion traces on the outer surface of XB-23 tail shaft 230-1526-000, as well as blistering (swelling) of the paint coating (see figure 202) – perform an additional inspection of the outer surface of the tail shaft for cracks and corrosion damages using IIM-15B method with the participation of the specialists of JSC “Reductor-PM”. Inspection results must be included in the Inspection report (Appendix 2).

At that, in addition to the requirements of task card 065.10.00a, introduce a restriction to prevent the presence of corrosion traces, as well as blistering (swelling) of the paint coating (see figure 202) on the outer surface of the XB-23 tail shaft.

1.2 XB-23 tail shafts 230-1526-000 with the defects detected during inspections using IIM-15B method must be removed from operation and sent for repair.

In case of detection of defects, perform an additional inspection of the tail shaft outer surface for cracks and corrosion damages using LQM-15B method with the participation of specialists of JSC “Reductor-PM” (inspection results must be included in the Inspection report according to the Appendix No. 2), in case of detection of defects – tail shaft must be removed from operation and sent for repair.
