## AIRWORTHINESS DIRECTIVE

No. 2025-MI-8,171-01

Applicability – Mi-8,  
Mi-8AMT, Mi-171, Mi-171A2 Helicopters and their Modifications

On Inspecting 8AMT-4102-11 Universal Joint of Main Landing Gear Radial Rod Mi-8,  
Mi-8AMT, Mi-171, Mi-171A2 Helicopters and their Modifications, Manufactured by  
U-UAP, JSC  
2024

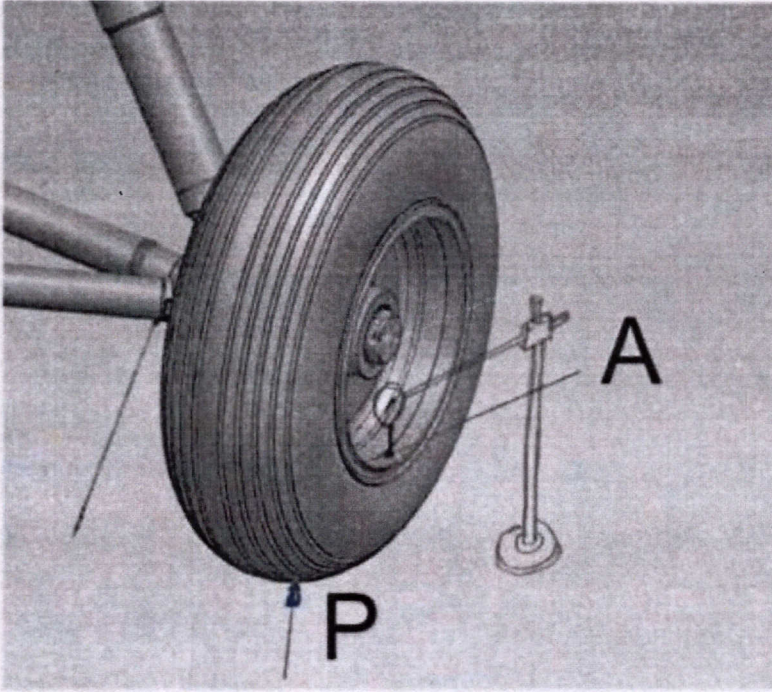
| <p>Fig. 1<br/>Measuring Total Vertical Play of Main Landing Gear</p> <ol style="list-style-type: none"> <li>6. Dismantle the wheel KT97-310.</li> <li>7. Put 246-9921-3100 type fixture on a horizontal platform in front of the wheel axle, as shown in Fig. 2.</li> <li>8. Using a dynamometer and a cord (lanyard) with a diameter of 6 ... 10 mm, apply a force of P1 = (15 ... 17) kgf by hand to the wheel axle (in the area between the mounting surfaces of the bearings) in the direction from 246-9921-3100 type fixture.</li> </ol> | | |

| <p>Measurement of total vertical and longitudinal play of main landing gear shall be performed in the following order:</p> <ol style="list-style-type: none"> <li>1. Perform preliminary operations, for which purpose put the helicopter on hydraulic jacks and lift it until the wheels are off the ground.</li> <li>2. Put the support of 246-9921-3100 type fixture on a horizontal platform near the wheel (at a distance 25 ... 50 mm), as shown in Fig. 1.</li> <li>3. Set the indicator ИЧ10 so that the tip of its rod rests with a slight tension on the wheel flange at point A and tighten the retainer wing nut, turn the dial to set the indicator pointer reading to '0'.</li> <li>4. Using a lever, apply force P3= (80 ... 100) kgf vertically upwards at the point of contact of the tire with the ground.</li> <li>5. Take indicator readings.</li> </ol> <p>Total vertical play value should not exceed 8.00 mm.</p> | | <p>If the total longitudinal and/or lateral play is exceeded, visually determine the assemblies with the greatest play by sharply shaking the landing gear by the wheel in the longitudinal and vertical direction. Dismantle the units and parts with worn-out assemblies. Perform micro measurement of the parts that form the worn-out assemblies. Repair the assemblies by installing repair bolts and by boring the appropriate holes in the parts up to the required size. At the same time, follow the Fits and Clearances Manual for Mi-8 helicopter.</p> |

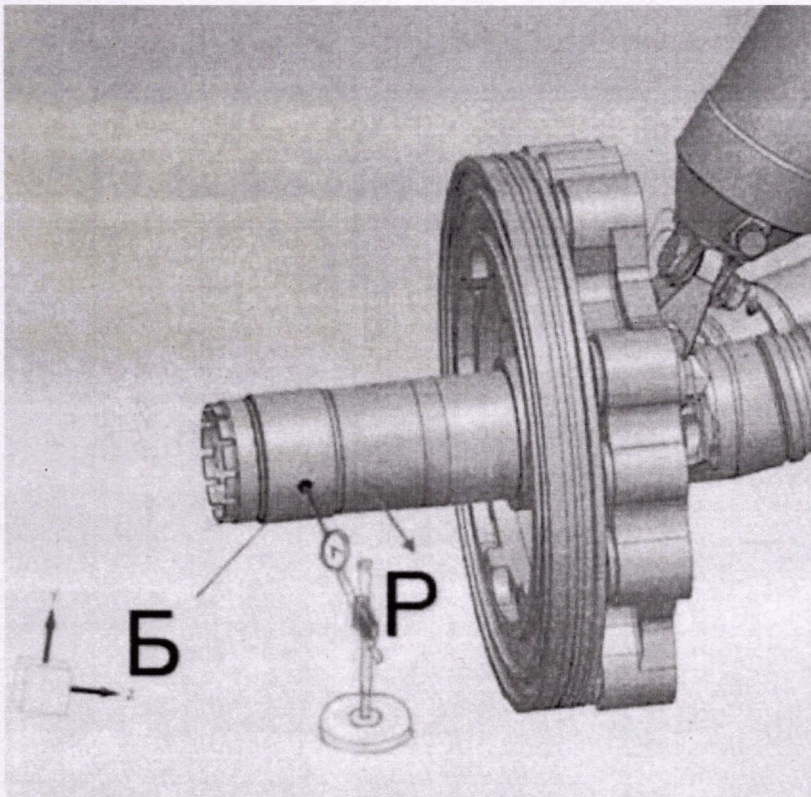
| Procedure and Technical Requirements (TR) | | Corrective Actions | Checked by |
|---|---|---|---|
| <p>9. By moving the retainer along the slider or moving the fixture itself, set the indicator ИЧ10 so that the tip of its rod rests with a slight tension on the cylindrical part of the wheel flange at point Б and tighten the retainer wing nut, turn the dial to set the indicator pointer reading to '0'.</p> <p>10. Take off the tension P1 and apply the tension P2 = (15 ... 17) kgf in the opposite direction.</p> <p>11. Take indicator readings.<br/>Total play value should not exceed 8.00 mm.</p> | | | |

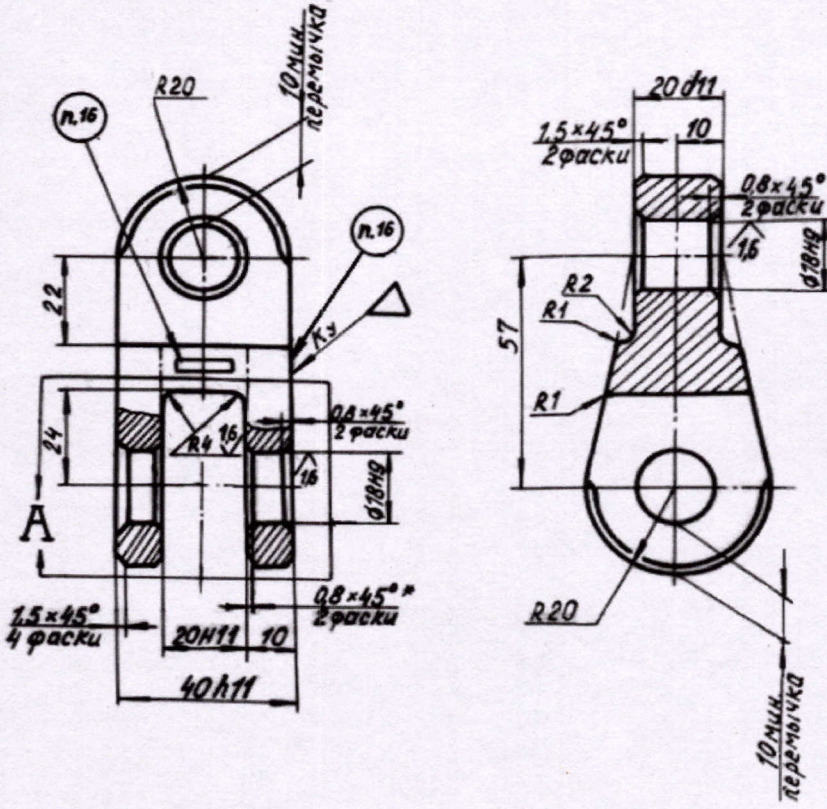
8AMT-4102-11 Universal Joint (ref. fig. 1 of TC No. 2) is a part with outline dimensions of 40×40×97 mm of 30ХГСА pressed steel. The material hardness after quenching is 35.5...40.5 HRC. Fork eyes surfaces, radius blends R4 are strengthened by cold hardening after thermal treatment. The assigned service time of 8AMT-4102-11 universal joint is not determined. Operating 8AMT-4102-11 universal joint shall comply with the time limits of the airframe, where the universal joint is installed.

| <p>Dismantle the universal joint from the main landing gear.<br/>Clean the universal joint from dust, dirt and grease by cloth and wash it in petrol Nefras. Get it dry.<br/>Measure dimensions Ø18H9 (in the longitudinal and lateral planes of the part), 20d11, 20H11 with accuracy 0.01 mm.</p> <p>Fig. 1 – 8AMT-4102-11 Universal Joint Sketch</p> <p>Perform non-destructing testing by dye penetrant inspection method for cracks, paying special attention to the places of fillets R4.</p> | | <p>When the dimensions of Ø18H9 (measured in longitudinal and lateral planes of the part) deviate beyond the tolerance field more than 0.15 mm, this assembly should be repaired by Aircraft Repair Plant specialists according to the Overhaul Manual.</p> <p>When the dimensions of 20d11, 20H11 deviate beyond the tolerance field more than 0.1 mm, the part should be rejected.<br/>If there are cracks, the part should be rejected.</p> | |

The universal joints that are manufactured with deviations from the values as per Task Card No. 2, or the items with detected cracks are to be replaced by the new ones (the first category).
