**AIRWORTHINESS DIRECTIVE**

No. 2025-FATA-010144R-05

Applicability – ANSAT helicopters (ANSAT, ANSAT-GC models) and their modifications

**TECHNICAL DECISION No. 1/144-2023-KB3**  
on continued airworthiness of the ANSAT helicopters (ANSAT, ANSAT-GC models)  
**Issue 2**

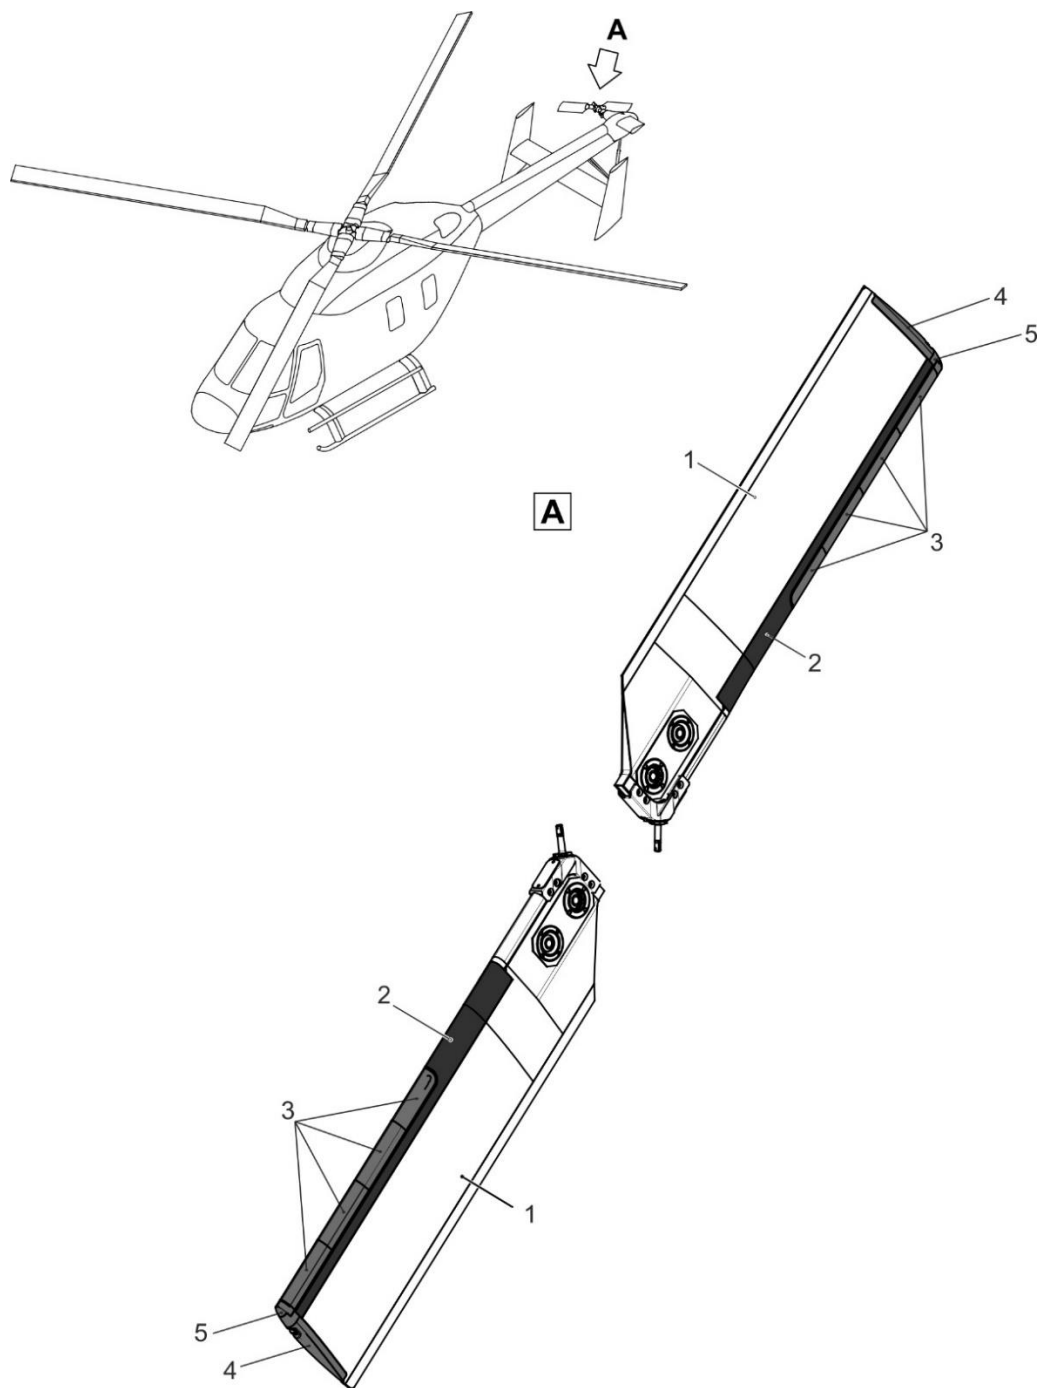
Figure 202 – Tail rotor blade

- defects of the blades in the form of non-glueing of the rubber layer of strips (2), blade edge tippings (3), as well as tips (4) and blade edge tippings (5) (see fig. 202, Appendix 2), exceeding the permissible ones according to the temporary task card 064.10.001,

shall be removed from the operation and sent to JSC "Kazan Helicopters" for the purpose of investigation and repair.
