## **AIRWORTHINESS DIRECTIVE (AD)**

No.2024-FATA-02074(16-Д)-05

Applicability – PS-90A, PS-90A-76, PS-90A1 Type Engines

**on Continued Airworthiness of the PS-90A, PS-90A-76, PS-90A1 Engines**

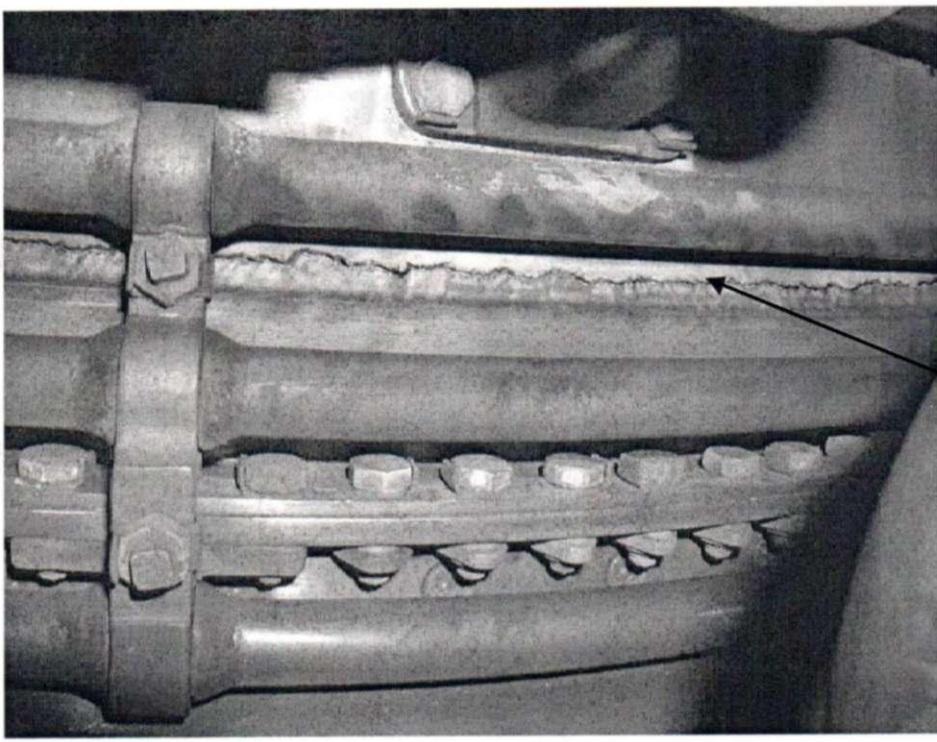
Figure 603ж. Type of crack on the 2<sup>nd</sup> St. nozzle vanes assembly (1 of 2)

| Description of Operations and Technical Requirements | <p data-bbox="1300 1500 1380 1534">Crack</p> |

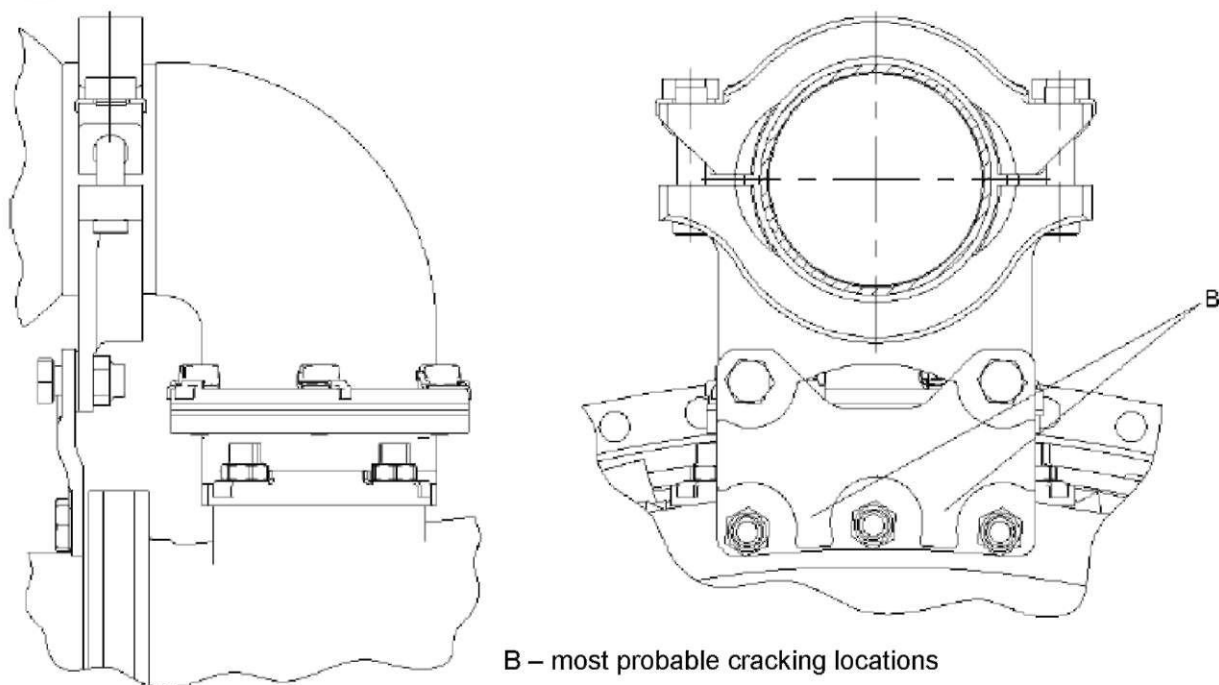
Figure 4 Inspection of IPS control lever bracket

B – most probable cracking locations

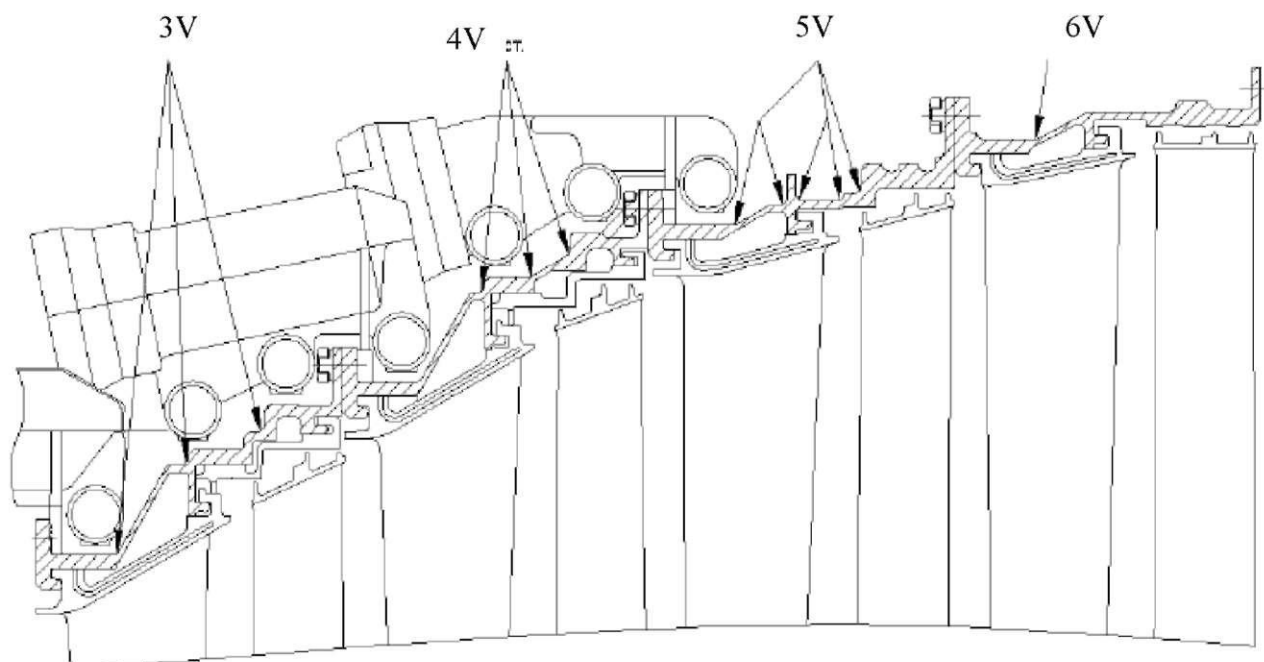
Figure 5 Turbine nozzle vanes assembly cases inspection locations

During inspection of turbine 2-6th stage nozzle vanes assembly cases for no cracking pay special attention to the zones shown in Figure 5. Also pay attention to the zone for vanes inspection on the 2nd stage nozzle vanes assembly. The locations of potential cracking on the 2nd stage nozzle vanes assembly case are presented in Figures 6 and 7, and those near the vanes inspection hatch – in Figure 8.

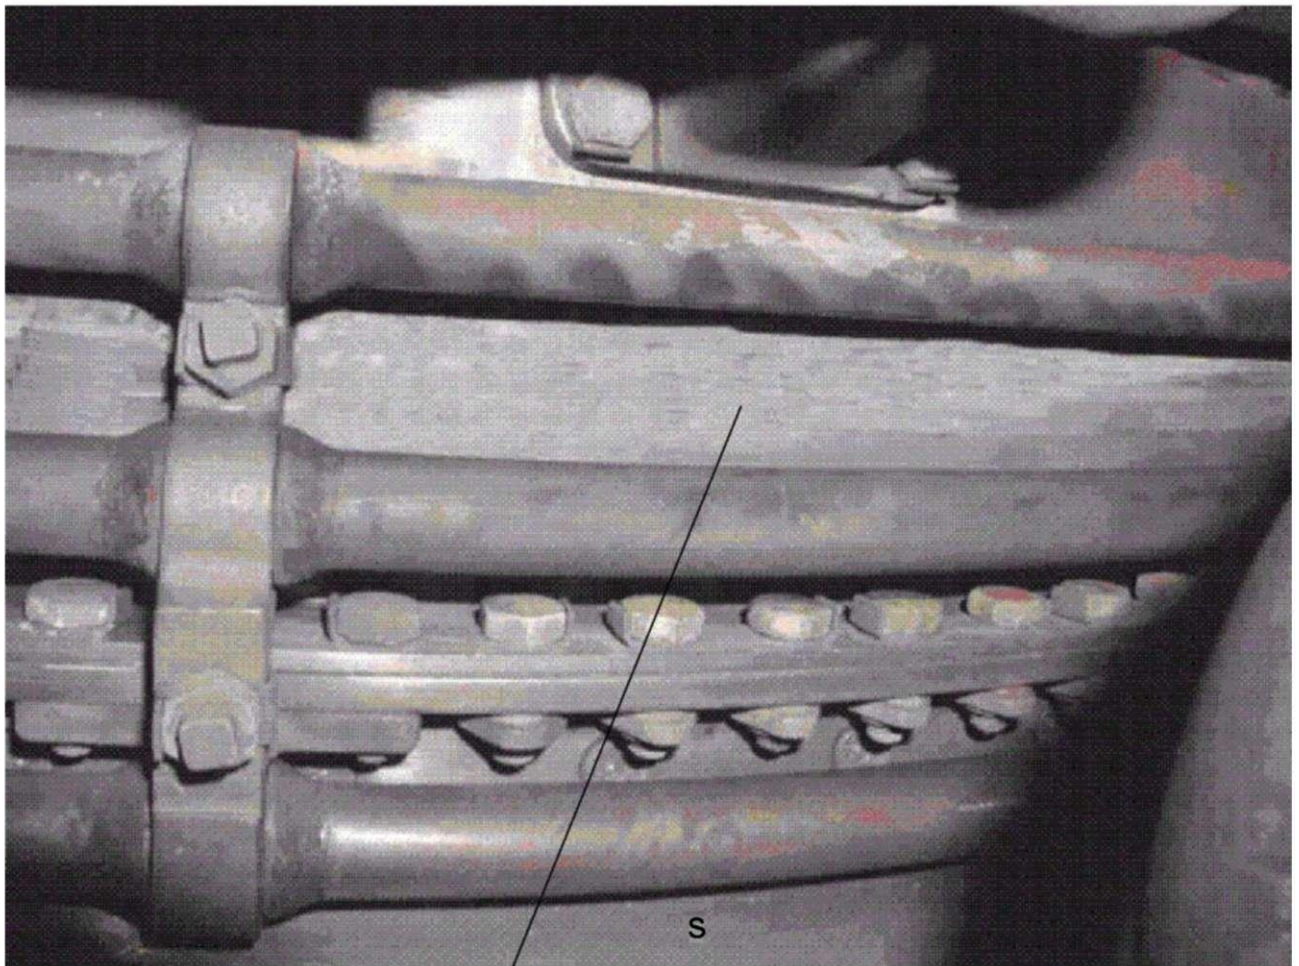
Figure 6 Turbine nozzle vanes assembly cases inspection locations. 2nd stage nozzle vanes assembly case.

1 Potential cracking locations

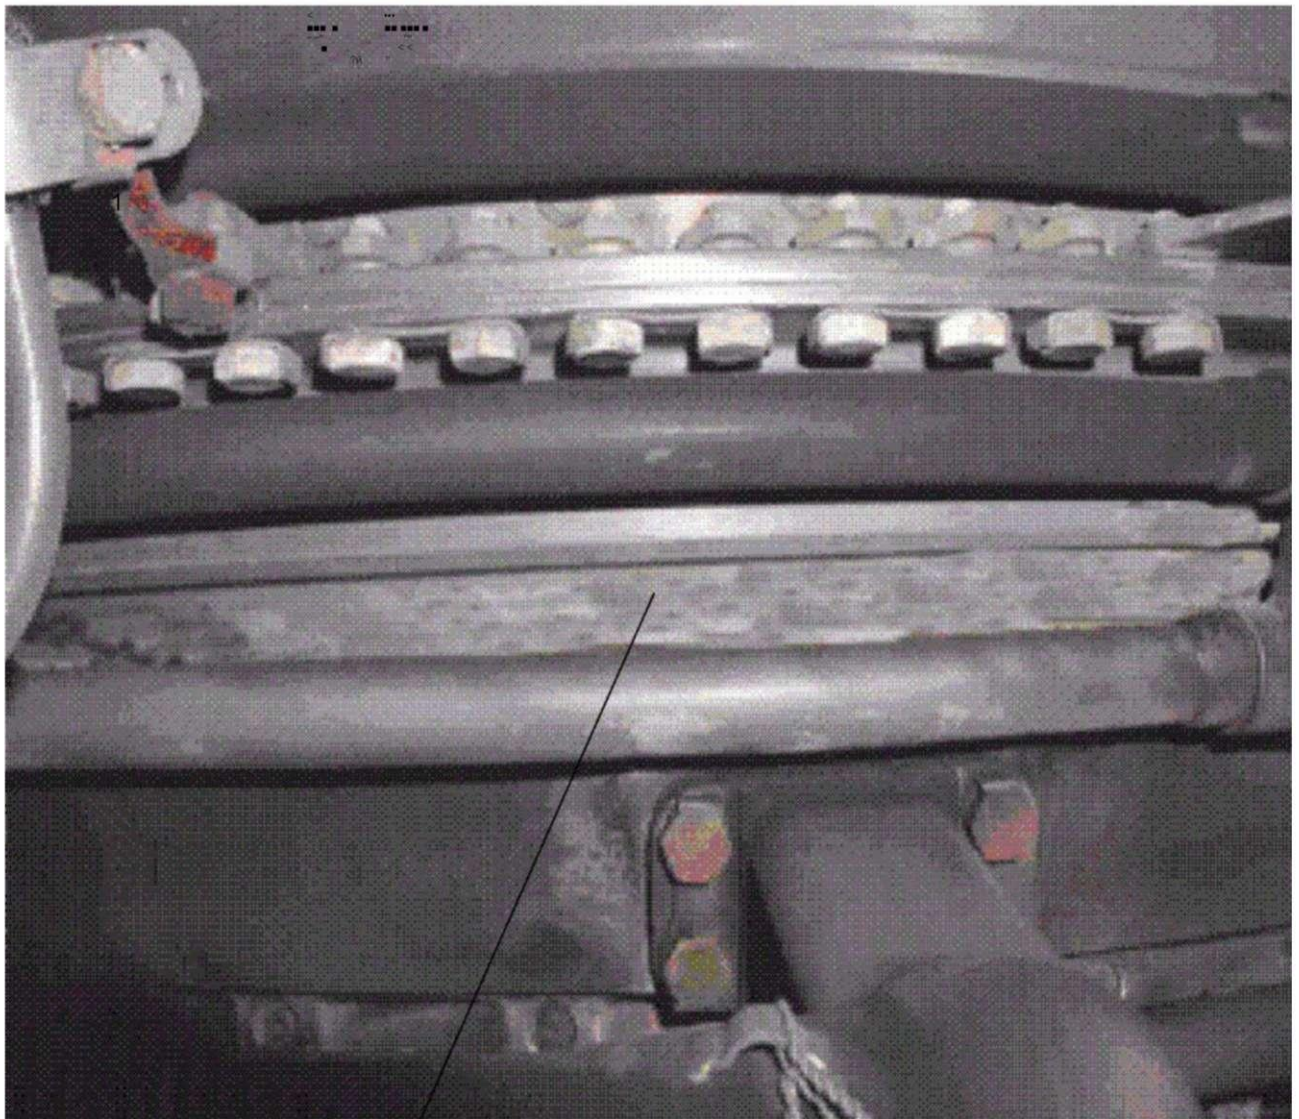
Figure 7 Turbine nozzle vanes assembly cases inspection locations. 2nd stage nozzle vanes assembly case

1 Potential cracking locations

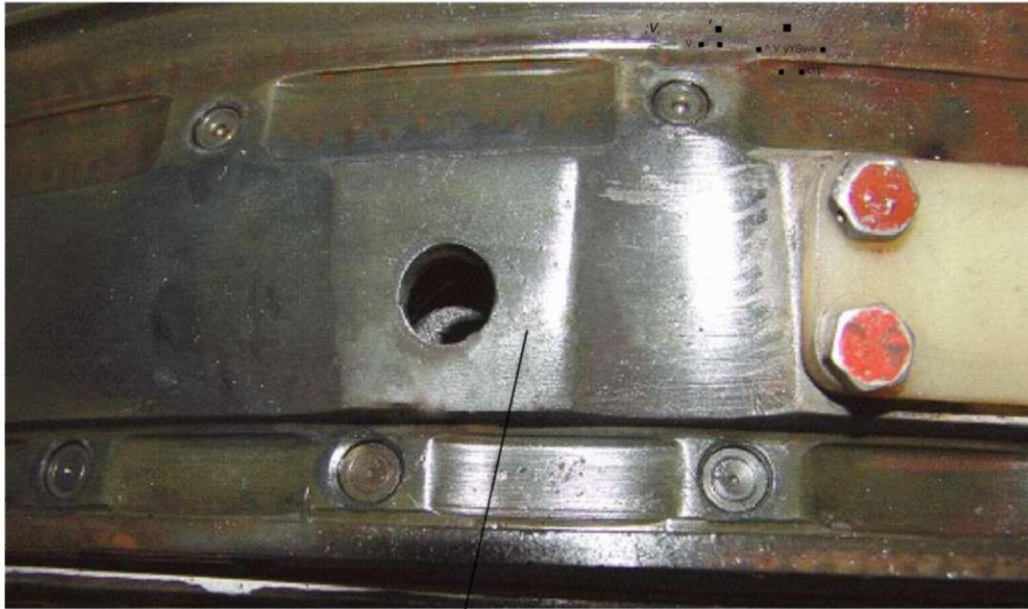
Figure 8 Turbine nozzle vanes assembly cases inspection locations. Vanes inspection hatch

1 Potential cracking locations
