## **AIRWORTHINESS DIRECTIVE (AD)**

No.2024-FATA-02074(16-Д)-05

Applicability – PS-90A, PS-90A-76, PS-90A1 Type Engines

**on Continued Airworthiness of the PS-90A, PS-90A-76, PS-90A1 Engines**

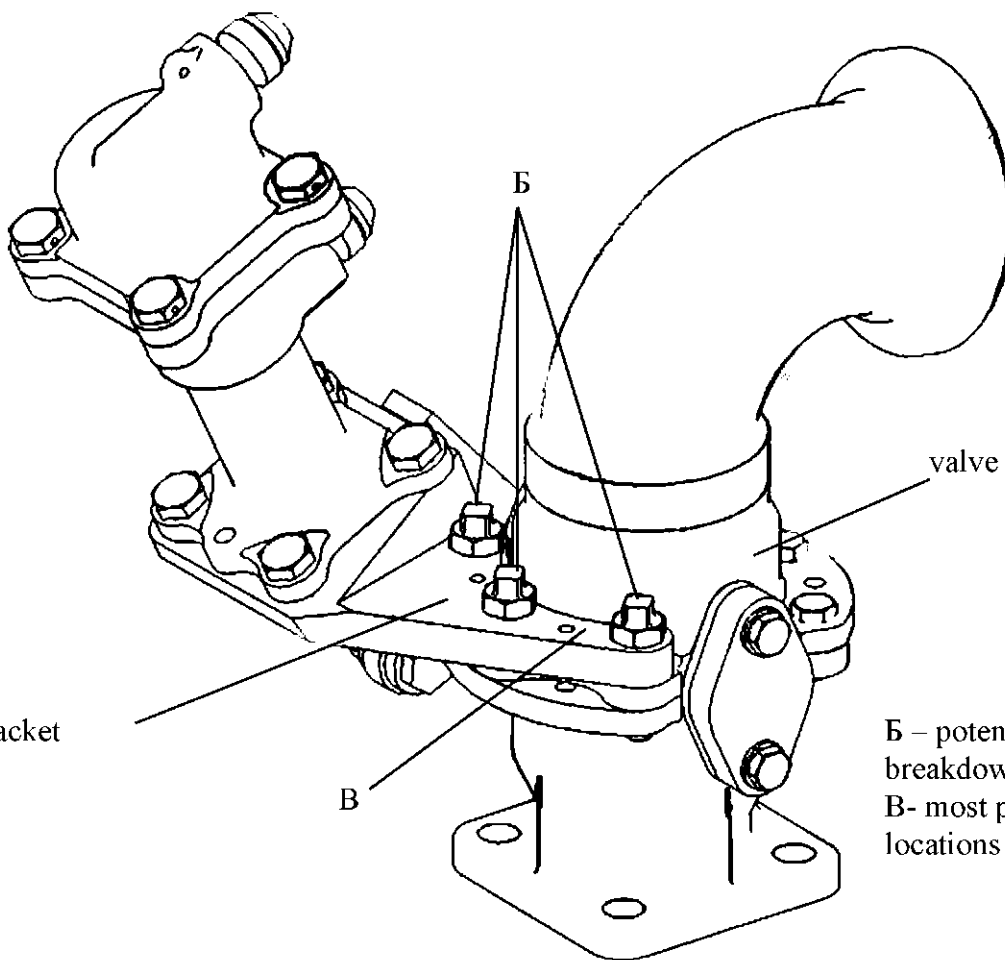
| Description of Operations and Technical Requirements | Works to be performed in case of noncompliance with Technical Requirements | Check |
|---|---|---|
| <div data-bbox="689 272 1960 1236"> <p>valve</p> <p>bracket</p> <p>B – potential screw head breakdown locations<br/>B- most probable cracking locations</p> </div> <p data-bbox="801 1329 1572 1369">Figure 6036 – Inspection of HPT 2B cooling valve brackets</p> | | |

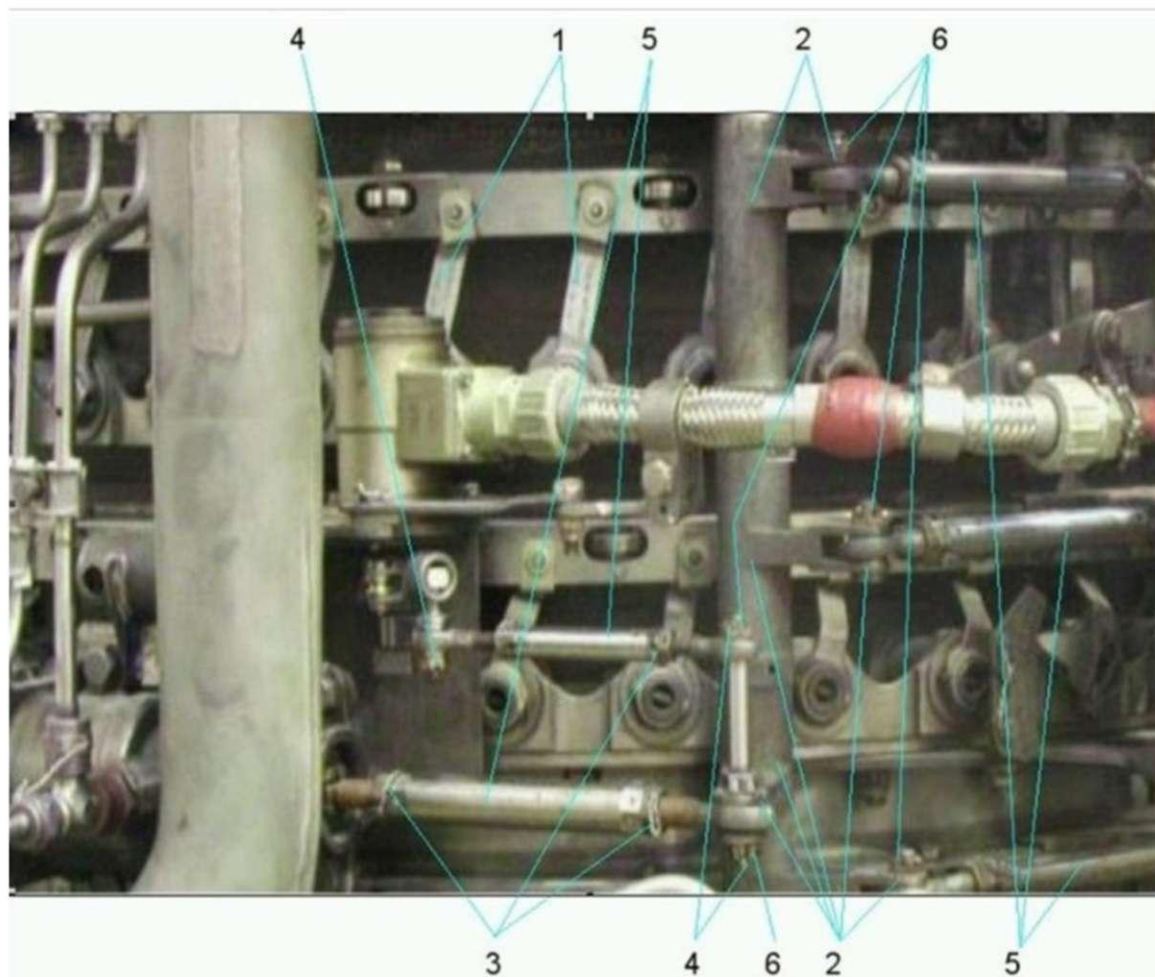
Figure 603л – Inspection of IGV, 1V and 2V control mechanism

- 1 – guide vanes turning levers
- 2 – tie-rods attachment levers
- 3 – locking wire

- 4 – locking pins
- 5 – tie-rods
- 6 – nuts

- cracking and damage of guide vanes turning levers 1
  - cracking and cleaving of levers 2 in tie-rods attachment locations
  - tie-rods 5 bending and slipping of threaded couplings on the tie-rods
  - loosening of nuts 6 in tie-rods and levers connections, no backlash
  - make sure that locking wire 3 and locking pins 4 are in place and intact

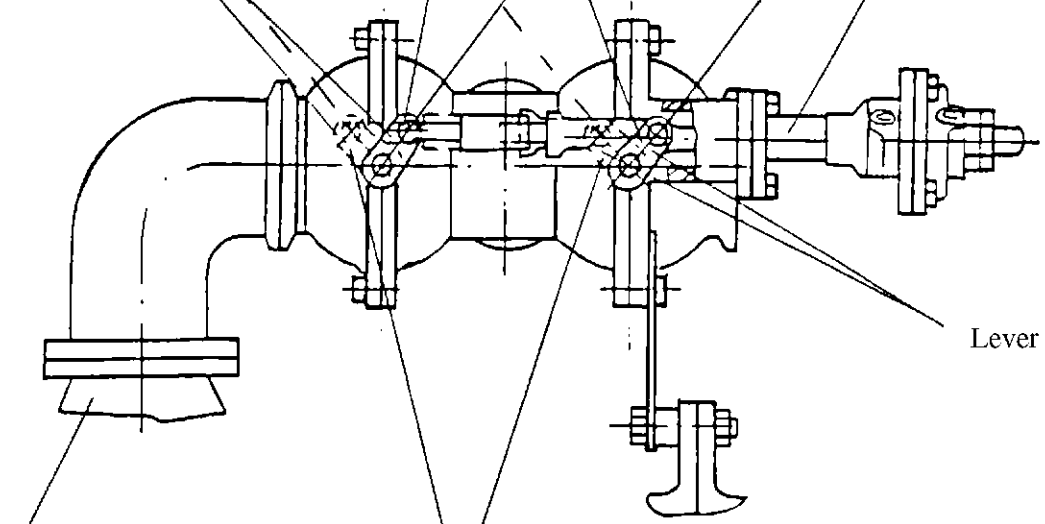
| Description of Operations and Technical Requirements | Works to be performed<br>in case of noncompliance with<br>Technical Requirements | Check |
|---|---|---|
| <div data-bbox="414 335 1915 1364"> <p>Parallel position of levers</p> <p>13<sup>th</sup> stage air bleed</p> <p>Parallel position of levers</p> <p>Hydraulic cylinder</p> <p>Lever</p> <p>Combustor case</p> <p>6<sup>th</sup> stage air bleed</p> </div> <p data-bbox="963 1412 1556 1444">Figure 603B. IPS control lever position inspection</p> | | |

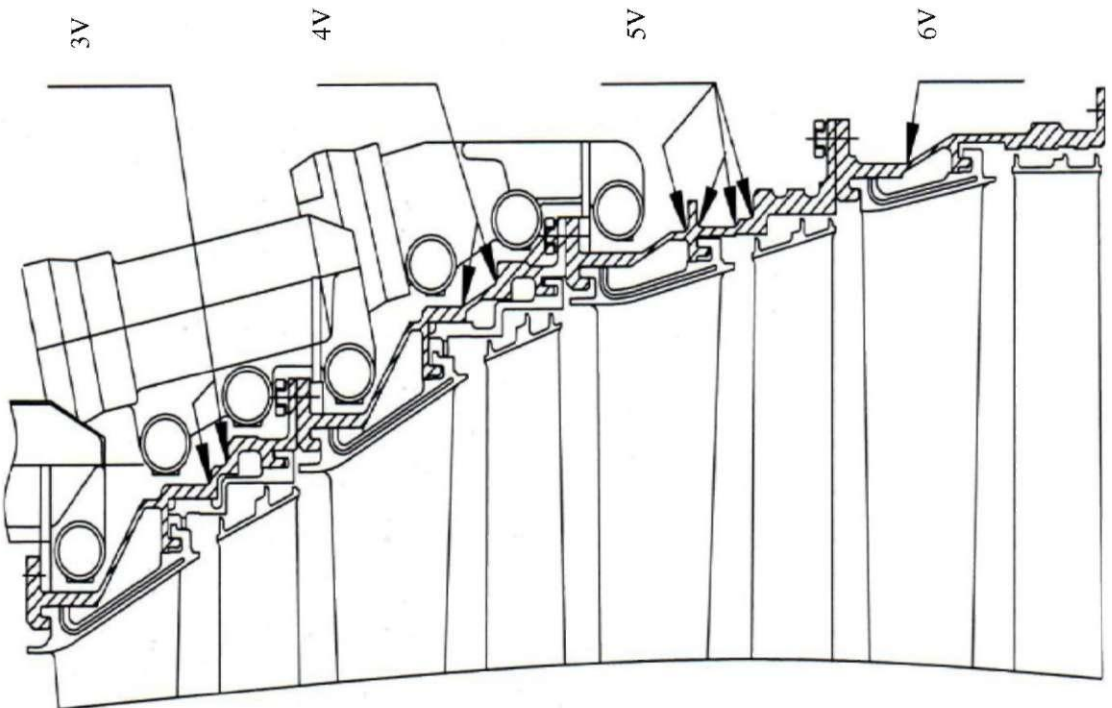
Figure 603e. Turbine nozzle vanes assembly cases inspection location

During inspection of turbine 2-6th stage nozzle vanes assembly cases for no cracking pay special attention to the zones shown in Figure 5. Also pay attention to the zone for vanes inspection on the 2nd stage nozzle vanes assembly. The locations of potential cracking on the 2nd stage nozzle vanes assembly case are presented in Figures 6 and 7, and those near the vanes inspection hatch – in Figure 8.

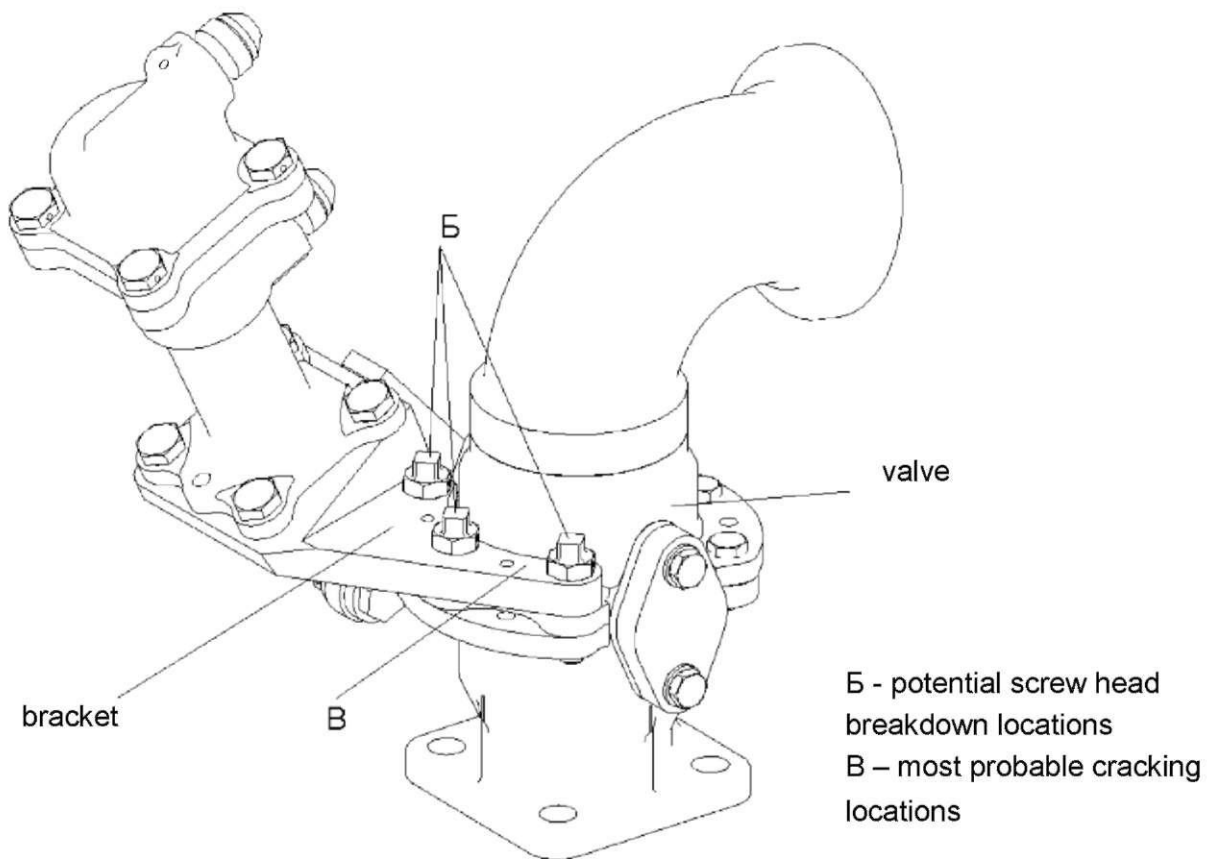
Figure 2 Inspection of HPT 2B cooling valve brackets

B – most probable cracking locations

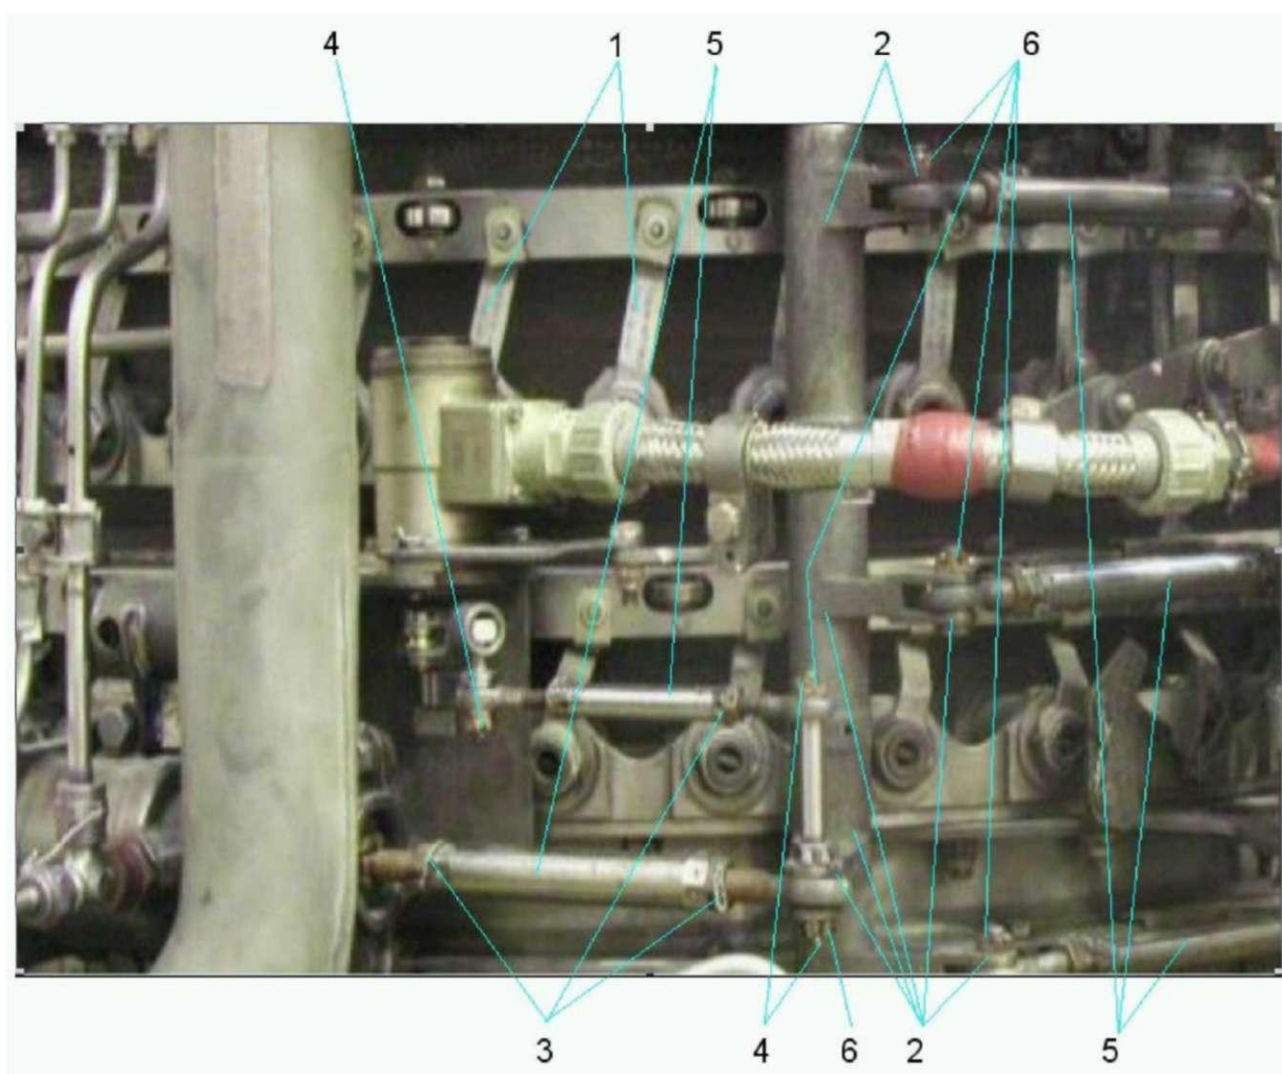
Figure 13 Inspection of IGV, 1V and 2V control mechanism

- 1 – guide vanes turning levers
- 2 – tie-rods attachment levers
- 3 – locking wire
- 4 – locking pins
- 5 – tie-rods
- 6 – nuts
